ASSUNPINK DAM

NO.19

NJ 00453

6 PHASE 1 INSPECTION REPORT
NATIONAL DAM SAFETY PROGRAM.

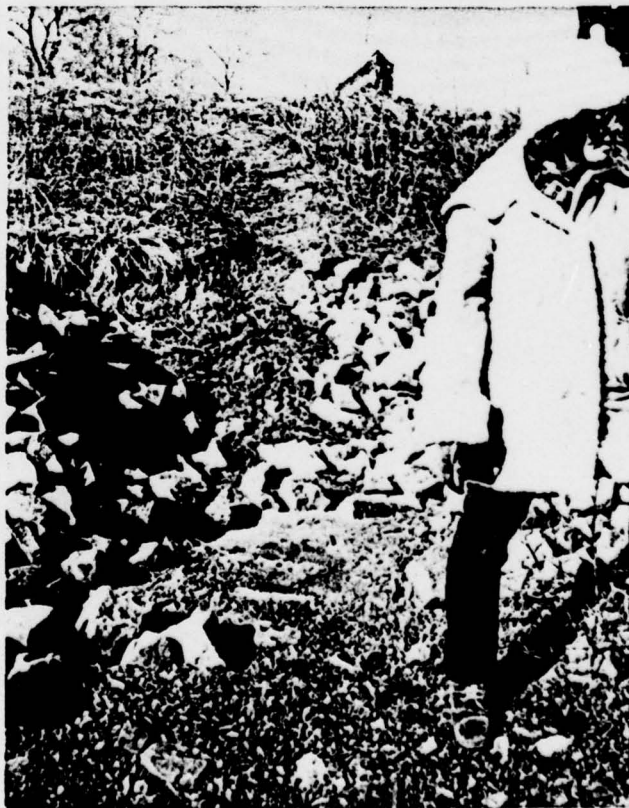
Displaced riprap directly opposite intake structure

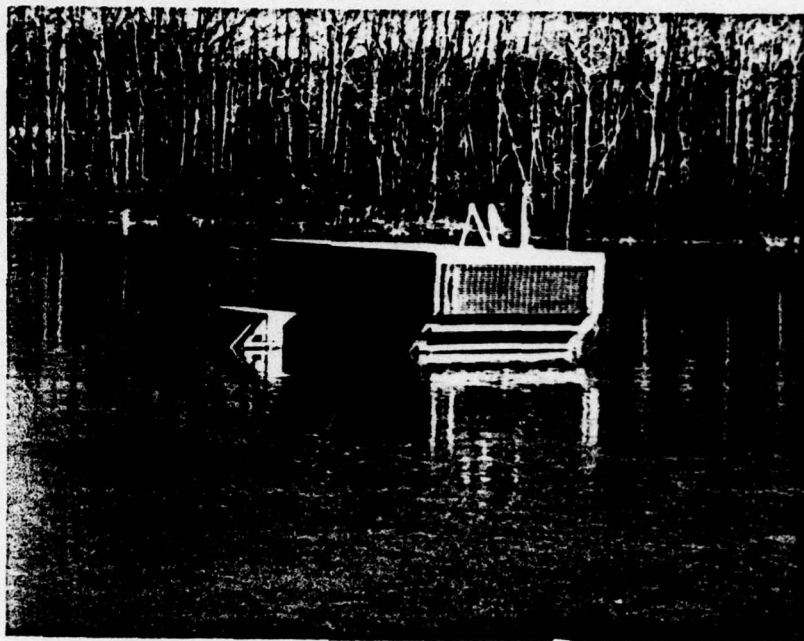
Intake structure

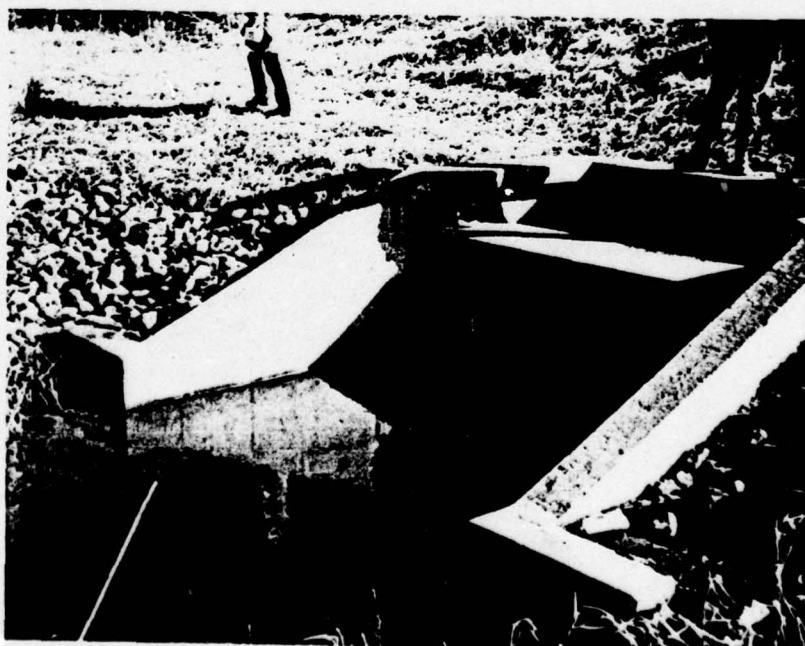
Outlet structure

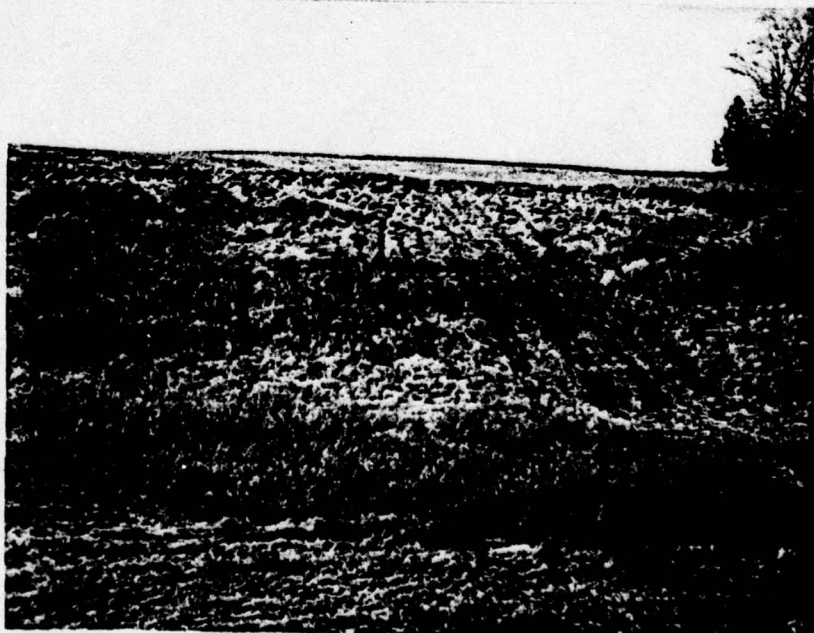
Erosion and vehicle tracks

- a. Repair and seed eroded areas on all slopes.
- b. Place additional barriers at access points around the perimeter of the dam to prevent erosion caused by unauthorized vehicular use of the dam surfaces.

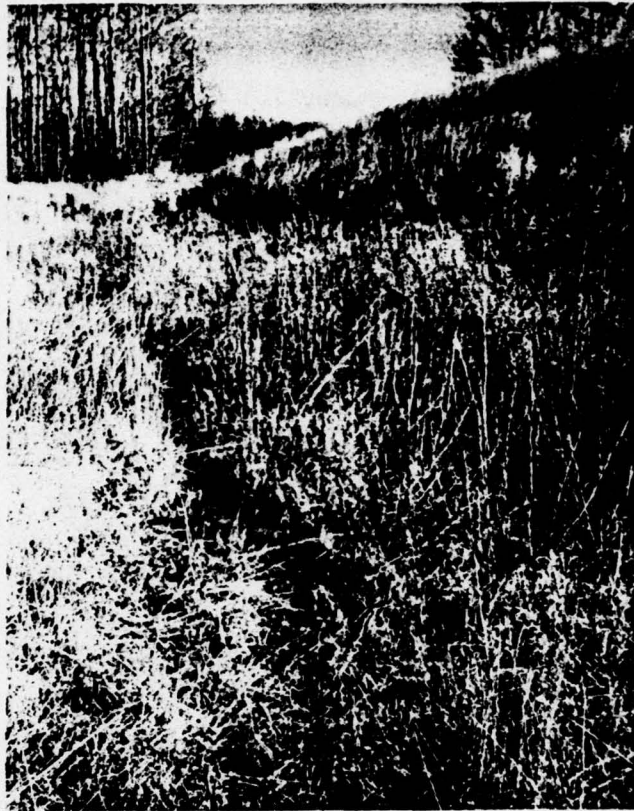
Seepage at toe of right embankment

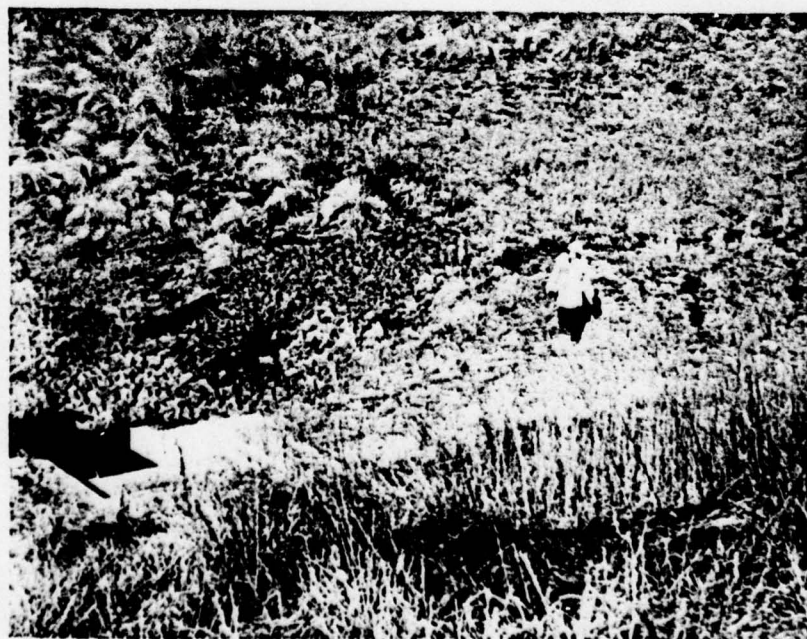
Repair of sloughed area
